**STEVENS POND OUTLET DAM**

**MA 00232**

**PHASE I INSPECTION REPORT  
NATIONAL DAM INSPECTION PROGRAM**

**AUGUST 1978**

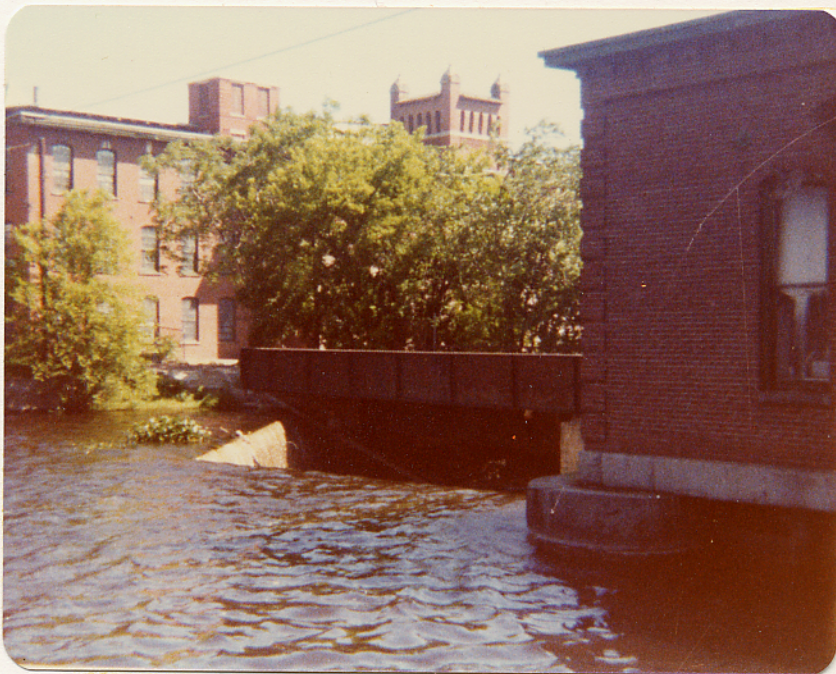
1

b. Dam. The over 100 year old dam is constructed on bed rock and is apparently in good condition. The granite block structure, although appropriately weathered, appears to be structurally sound. No significant horizontal or vertical misalignments were noticeable. Overflow prevents determining whether or not there is leakage through the joints. There is some growth at the left abutment and where the spillway joins the gate house on the right abutment.

Upstream View of Spillway  
from Right Bank

(5) The spillway should be inspected under a no-flow condition when possible.

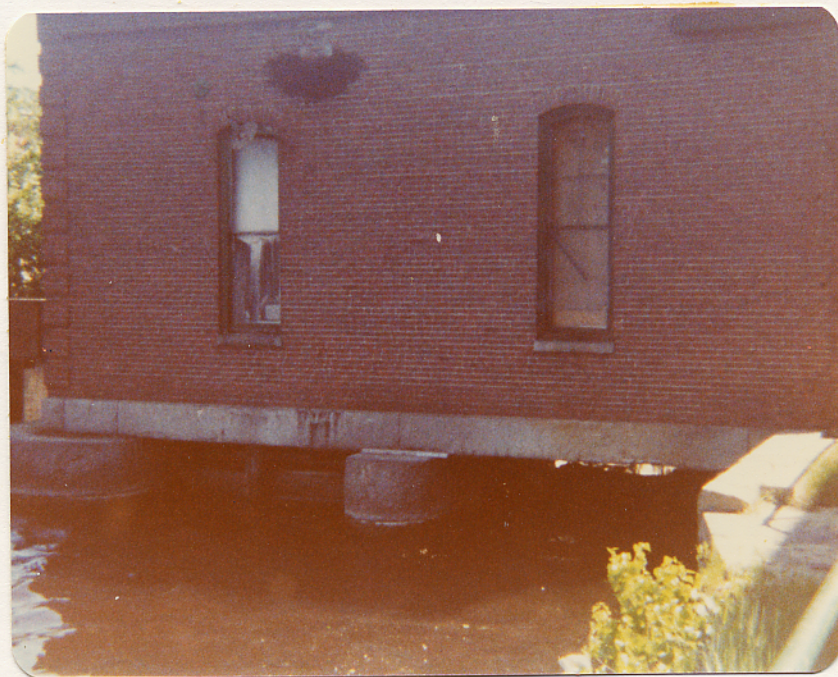
2

c. Appurtenant Structures. The only appurtenant structure, the brick gate house, appears to be in good condition in spite of some growth in the joints. The outlet works are said to be operable, although seldom used.

Upstream View of Gate House  
from Right Bank

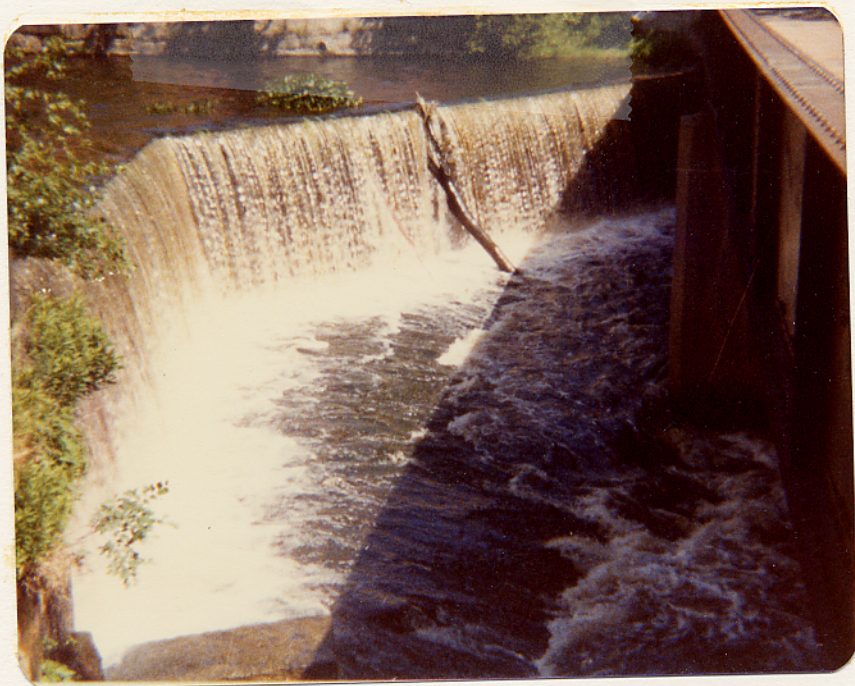
3

Downstream View of Spillway  
from Right Bank

(2) The channel between the dam and Broadway should be cleared, and kept clear, of growth and debris.

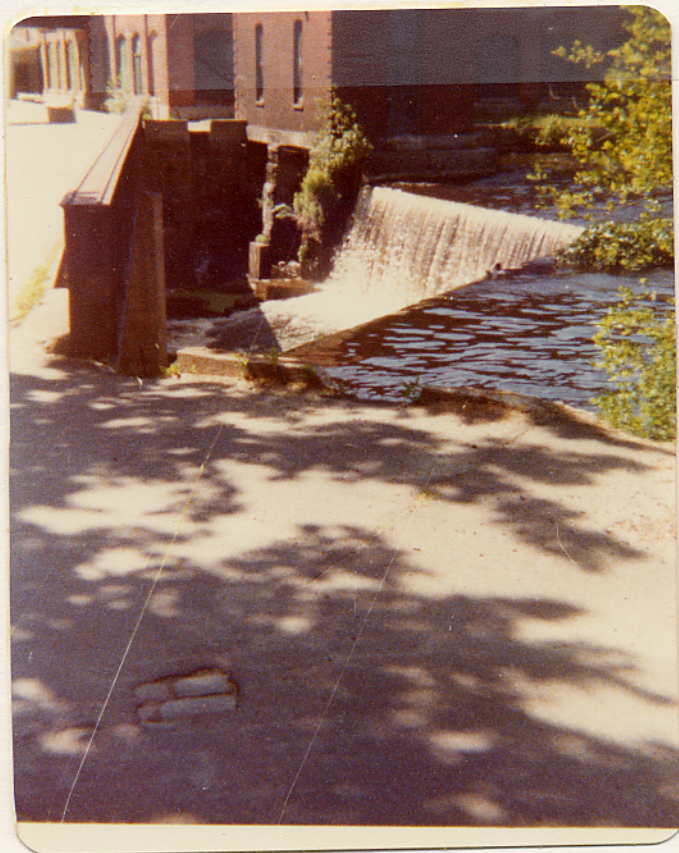
4

Downstream View of Spillway  
from Left Bank
